LAST CHECK
PRE PURCHASE MOTOR INSPECTIONS

SAMPLE INSPECTION REPORT

Make: Audi

Model: Q8

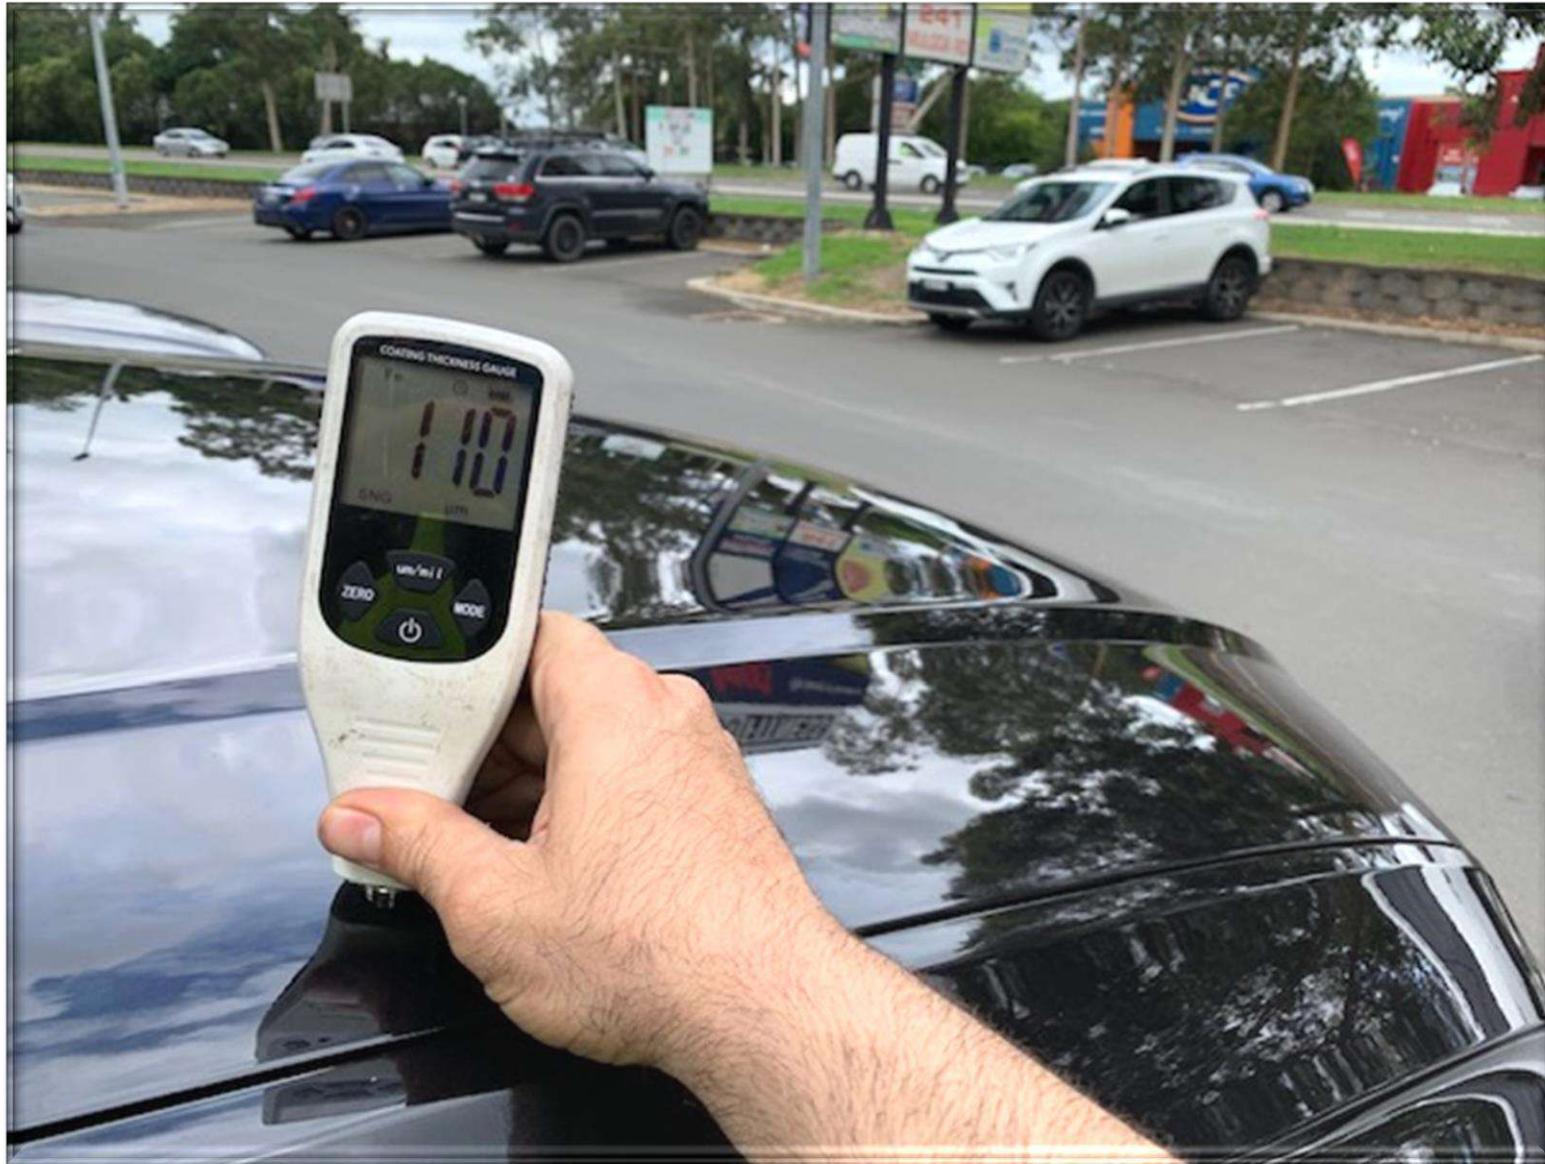
PAINT & RUST ASSESSMENT

- The engine had excessive Blowby _ it will be costly to repair as the engine block will need opening and closing to fix the issue.
- The right side of the car, roof, bonnet and tailgate have been resprayed in the past and the paint job does not look professional. It only has cosmetic value but it can negatively affect the resale value of the car.

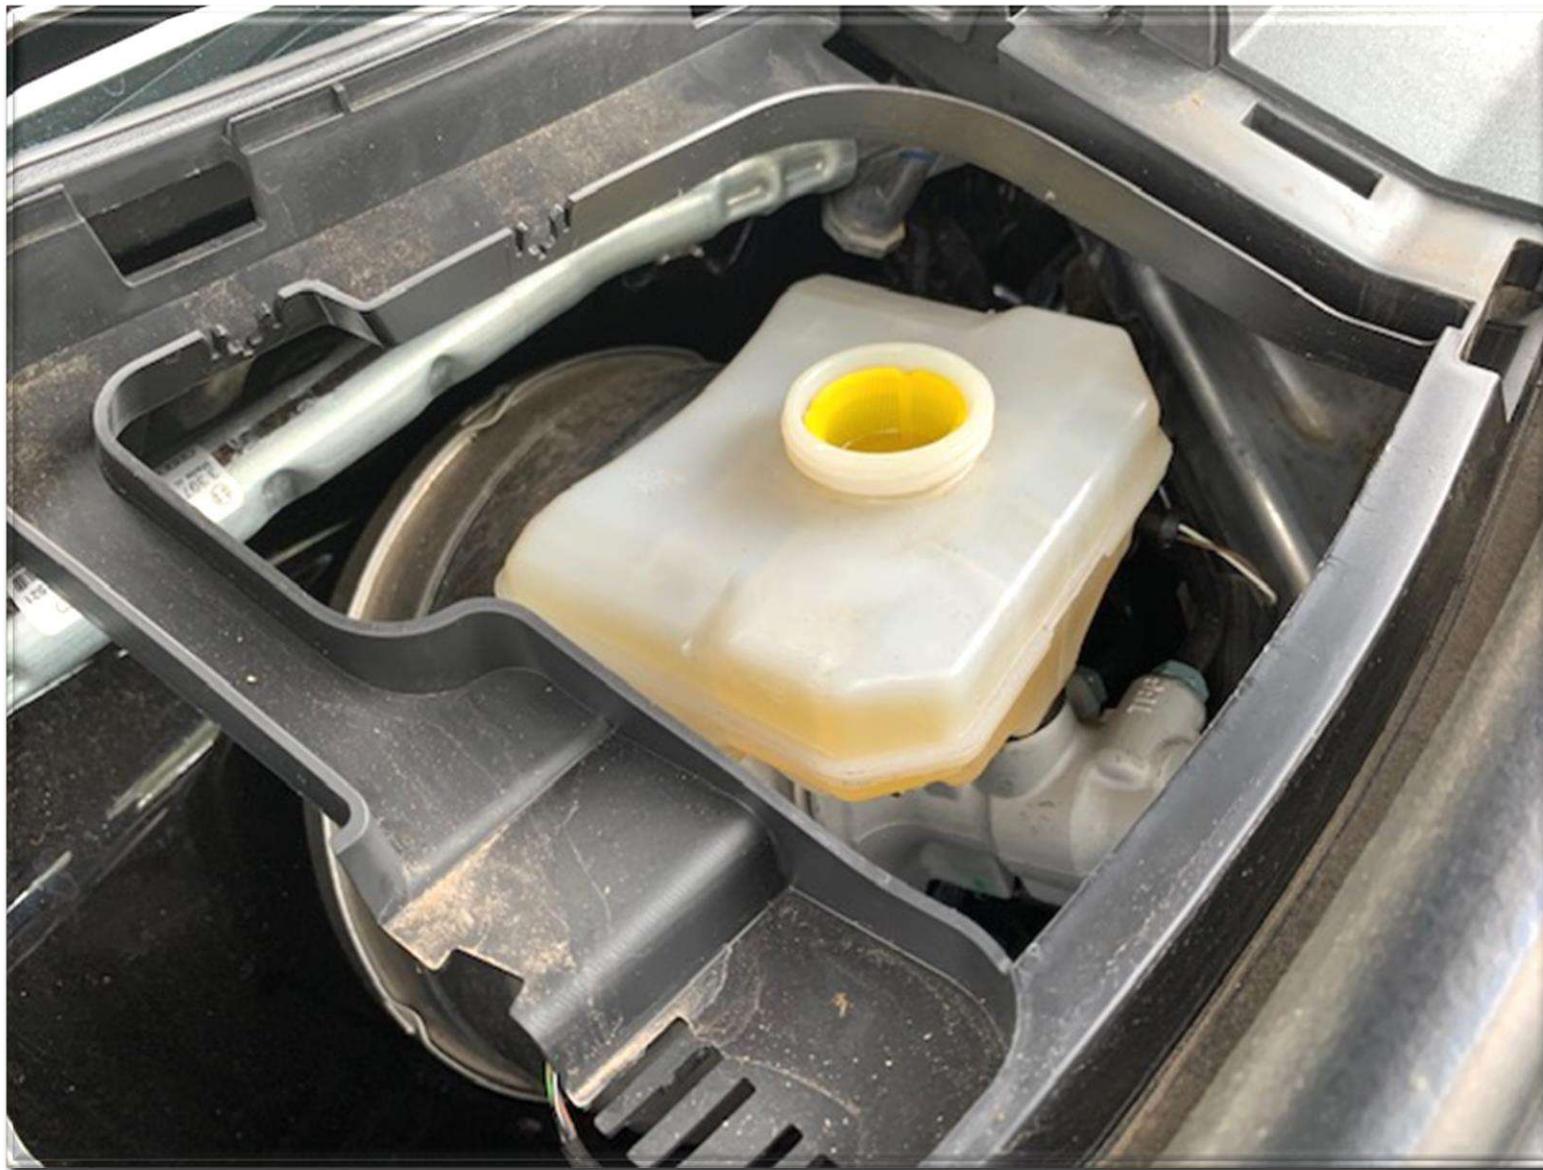
FLUIDS CONDITION

Engine Oil Condition: **POOR**

Engine Oil Level: **LOW**

- The engine oil and brake fluid need replacement and the normal service is due. We highly recommend using full synthetic engine oil for this model vehicle

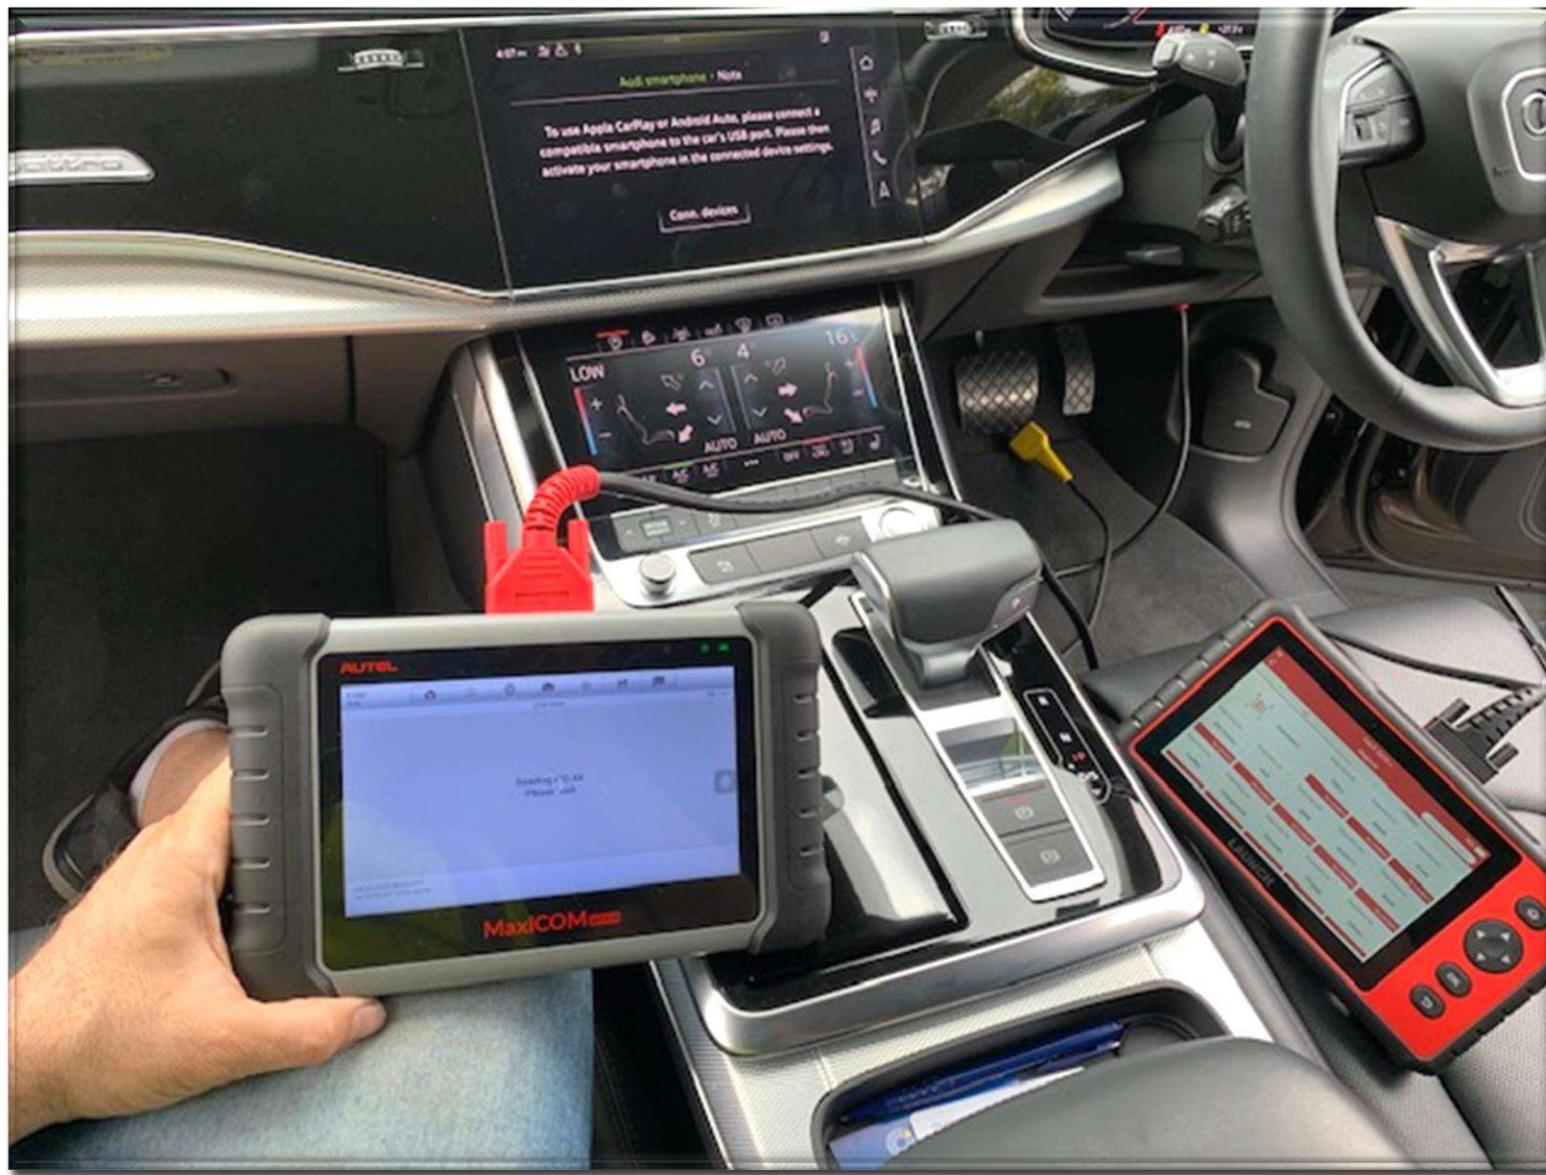
100% ORIGINAL COMPUTER DIAGNOSIS

Computer Fault Diagnosis: **2 ENGINE RELATED FAULT CODES FOUND**

Fault code 1: P0301 _ Cylinder 1 Misfire Detected

Fault code 2: P0327_ Knock Sensor 1 Circuit Low Input (Bank 2 or Single Sensor)
